FIRELINE RECLAMATION

TWO FIRE SITES

INTERIOR ALASKA

by Larry Knapman

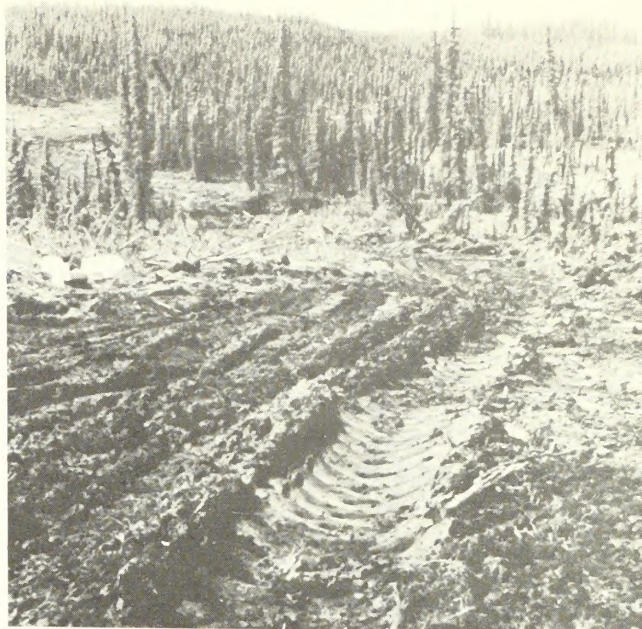
FIGURE 1. Ice in the ice-rich silt melted after the organic mat was removed during fireline construction. Photo was taken a few days after organic mat removal. Wickersham Dome fire, June 1971.

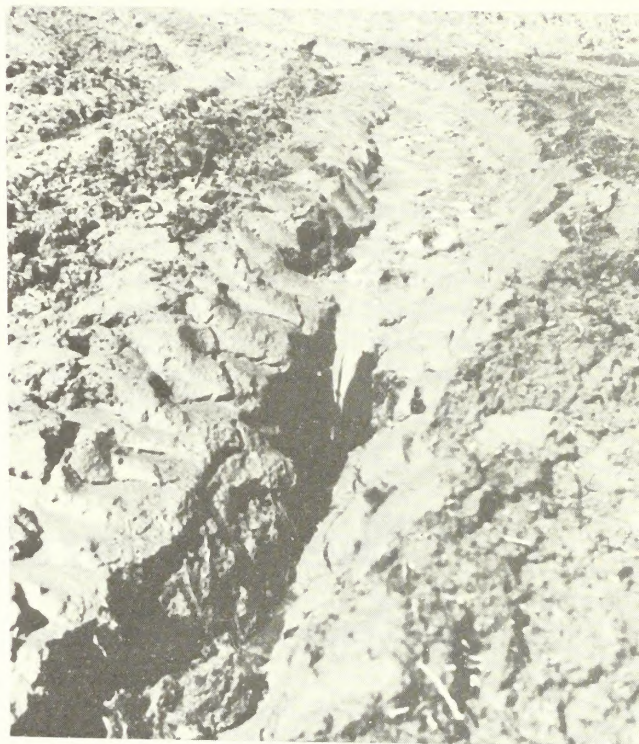
FIGURE 2. Heavy equipment tracks formed channels that collected runoff water from melting ground ice and precipitation in this fireline section of the Wickersham Dome fire. The channeling encourages head cutting, a form of continuing erosion.

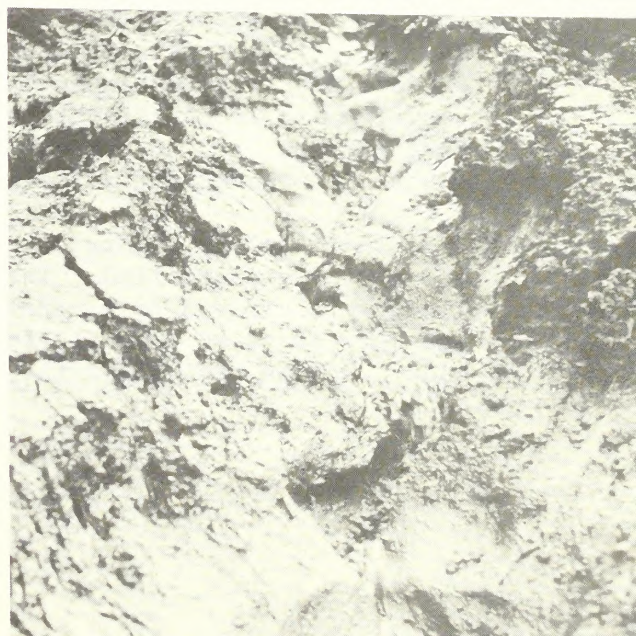
FIGURE 3. This fireline section is on a north-facing slope. The organic mat was removed 10 days earlier during fireline construction for the Wickersham Dome fire. Ice in the permafrost melted when the insulating organic material was stripped away. The melting was hastened by light rain that fell for several hours.

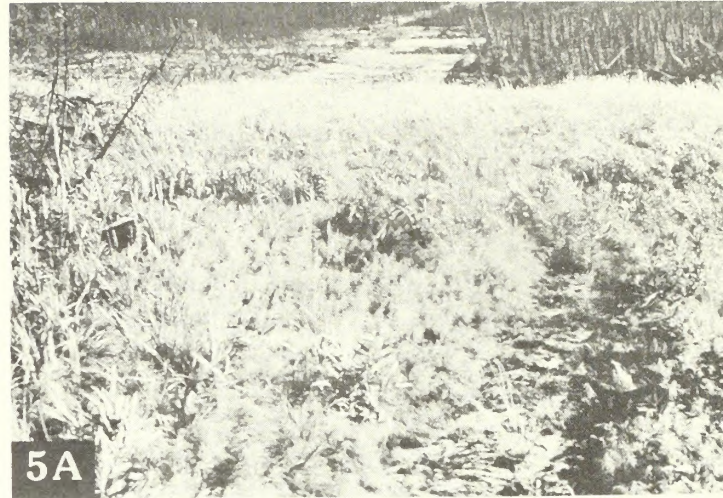
FIGURES 5A, 5B, and 5C show a fireline section on an east-facing slope. The site is wet and the original cover type was black spruce. Photos were taken from the same point 1, 4, and 7 years after the Wickersham Dome fire.

FIGURE 5A--August 1972--13 months after the fireline was built and 4 months after it was seeded and fertilized. No seeded species are evident, but very little erosion is taking place.

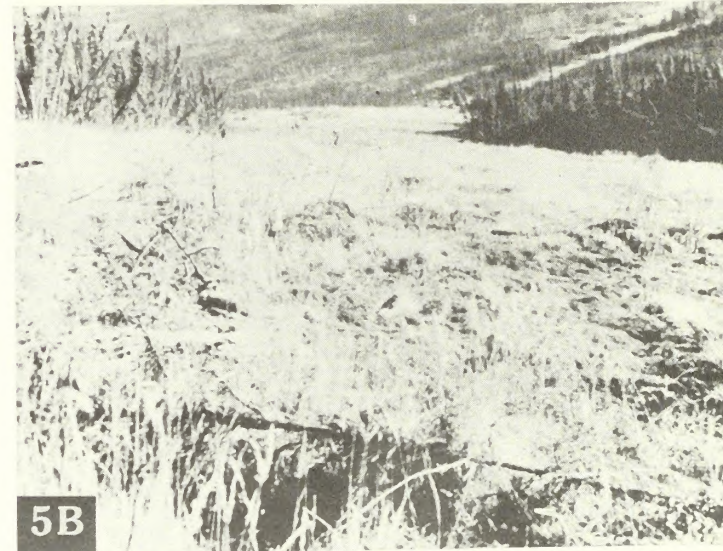
FIGURE 5B--September 1975. Ground cover is mostly mosses and horsetail. A moderate stand of bluejoint and willow is developing. Spruce seedlings are common.

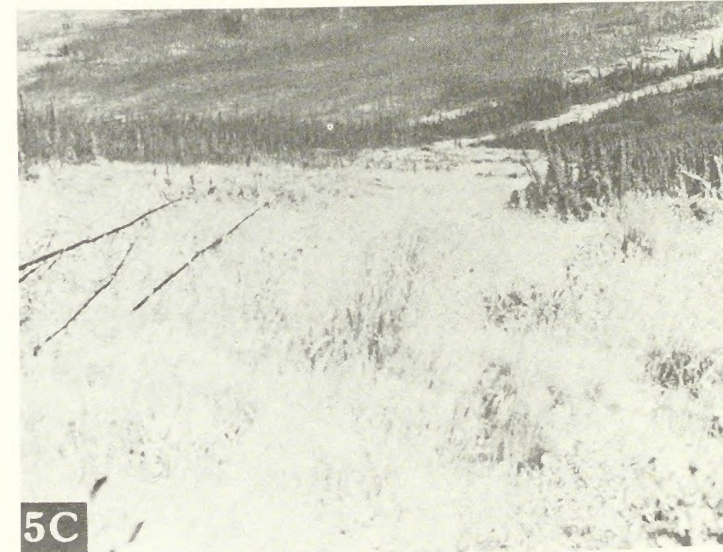
FIGURE 5C--September 1978. Mosses and horsetail are still the major components of the ground cover. Black spruce, willow, and bluejoint are increasing in density.

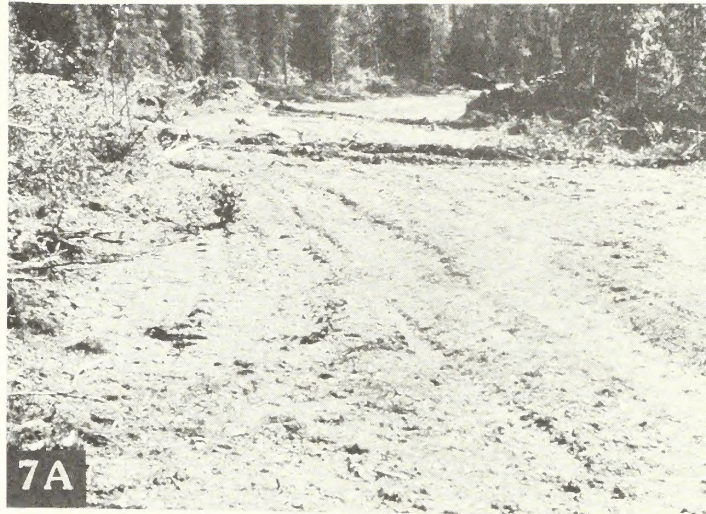
FIGURES 7A, 7B, and 7C show a fireline section on a well-drained, south-facing slope, with a spruce-aspen cover type. Photos were taken from the same point 1, 4, and 7 years after the Wickersham Dome fire.

FIGURE 7A--August 1972. Seeded species have reached a height of about one inch (2.5 cm). Only slight erosion is occurring.

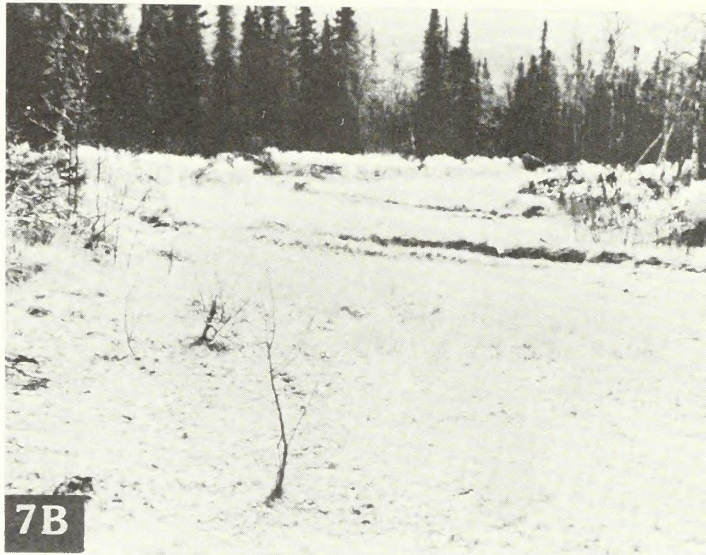
FIGURE 7B--September 1975. Seeded brome is the dominant species, but the percentage of ground cover is low.

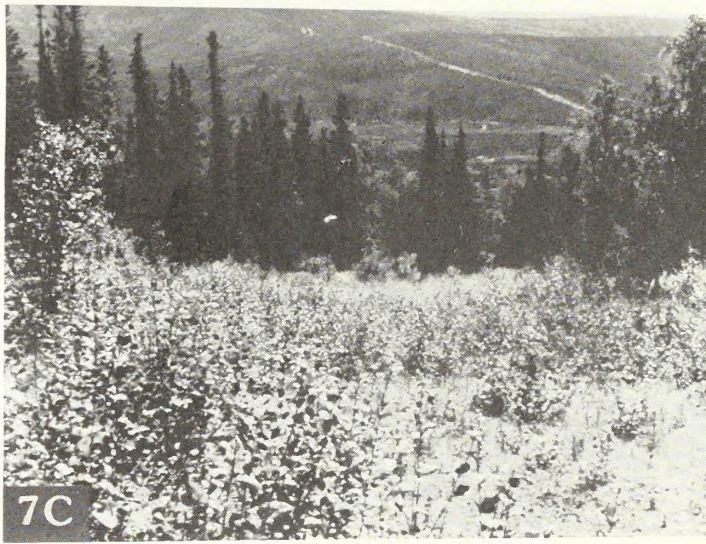
FIGURE 7C--September 1978. Ground cover still is only 50 to 60 percent. Very little brome grass has survived, and forbs are increasing. Willows, aspen, and alder have increased to form a shrub cover type.

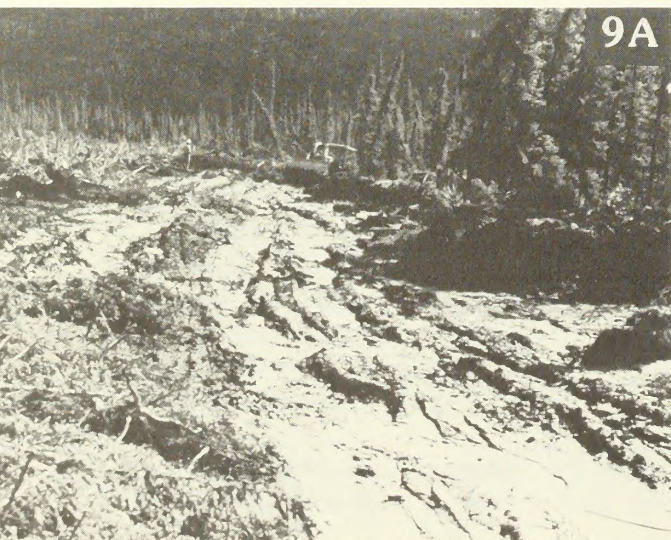
FIGURES 9A, 9B, 9C, and 9D show a fire-line section on the Alps fire. The line was constructed on poorly drained, fine-grained materials, on a very gentle east-facing slope with a black spruce cover type. This fireline was too wet to permit spreading berm materials by tractor. Therefore, the berms were pushed onto the mineral strip as waterbars. Care was taken to ensure that the waterbars contacted the vegetation mat well on both sides of the mineral strip. This segment of the line was seeded by hand but not fertilized.

FIGURE 9A--July 1975. The fireline before treatment that included seeding.

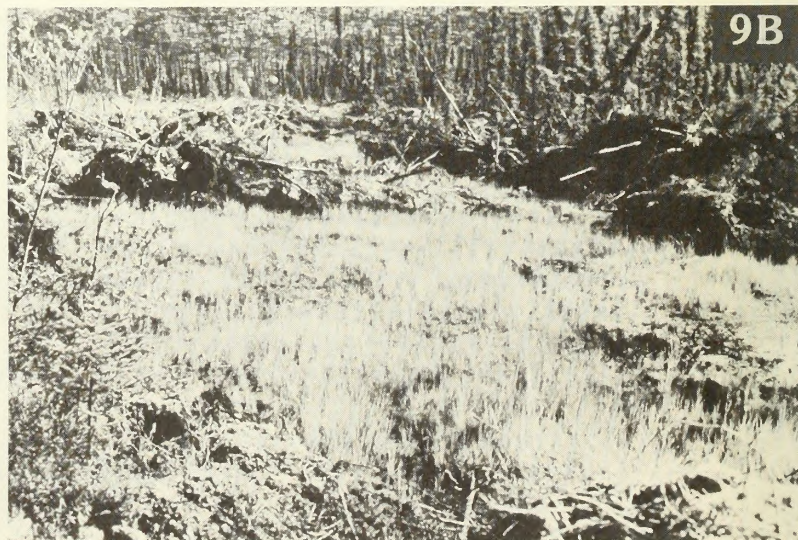
FIGURE 9B--August 1976. The fireline one year after treatment. We observed no significant erosion. Ground cover was mostly of seeded species.

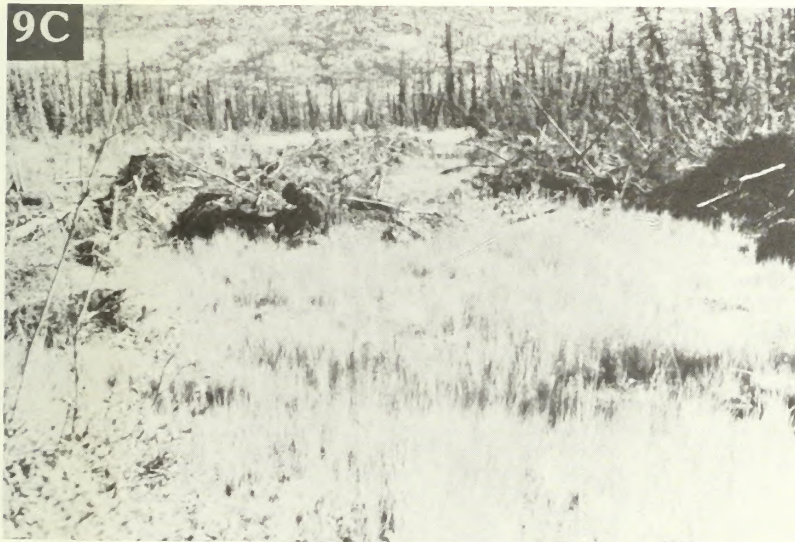
FIGURE 9C--September 1977. Seeded species continue to dominate.

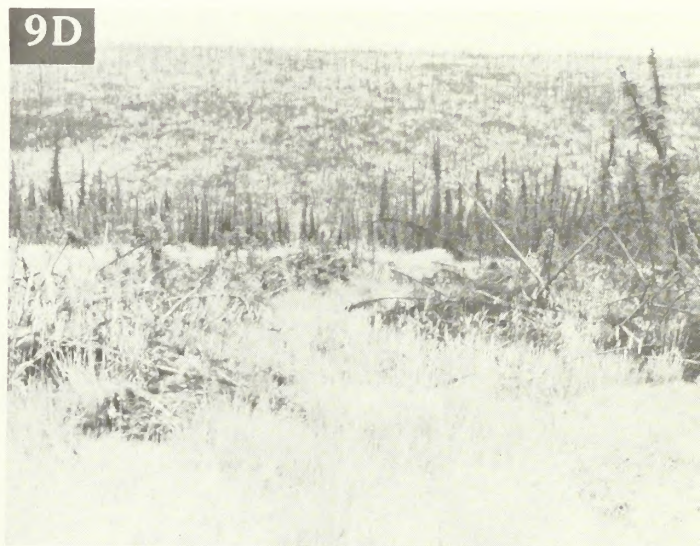
FIGURE 9D--September 1978. Some additional growth of native species is evident.

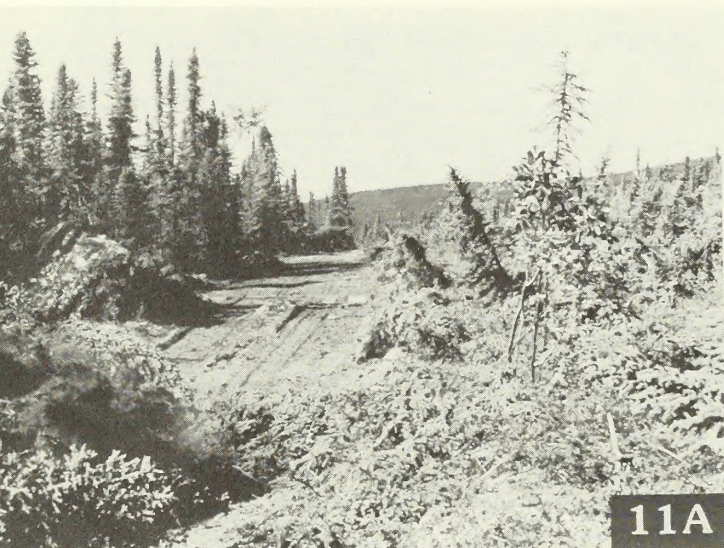
11A

FIGURE 11A--July 1975. The fireline before the berms were pushed back onto the mineral strip.

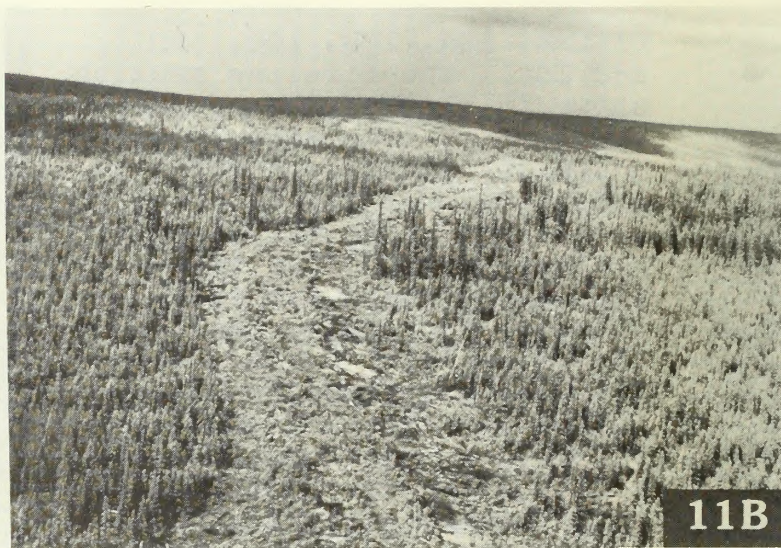
11B

Organic mat replacement immediately softened the visual impacts of the fireline (see

FIGURE 11B--August 1975. This aerial view shows the fireline after berms had been spread over the mineral strip. Covering the mineral strip with organic material not only retards erosion, but also makes the fireline less visible by reducing the "straight-line effect" or the stark contrast of a line through natural growth.

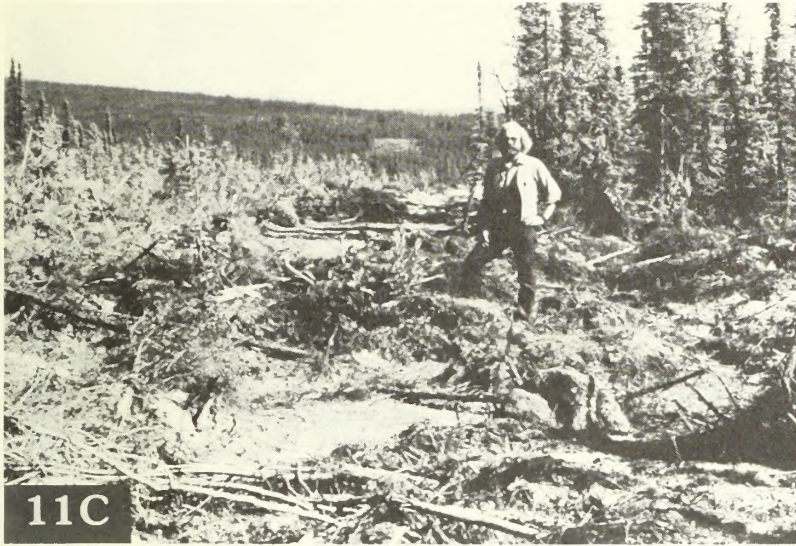
FIGURE 11C--August 1976. Because of the drouthy conditions of the site, revegetation is occurring mainly in soil clumps and patches that are protected from the wind.

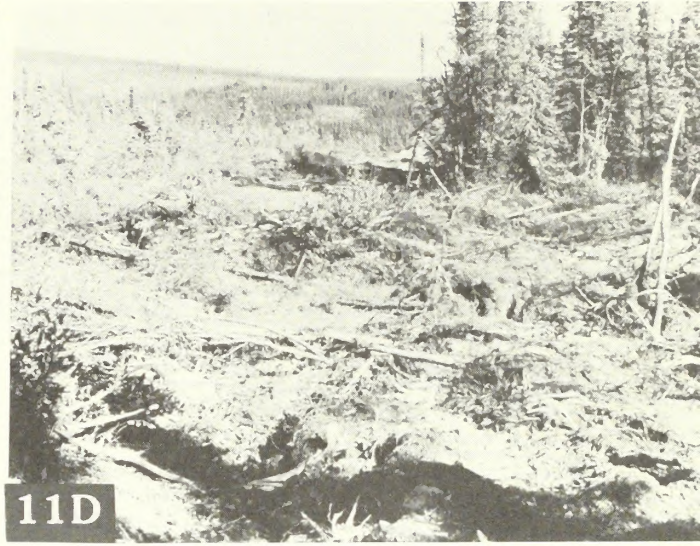
FIGURE 11D--September 1977. The fireline section is being re-colonized by grasses, mosses, willows, and black spruce. Moss invasion is greatest on bare soil that was protected from being wind dried.

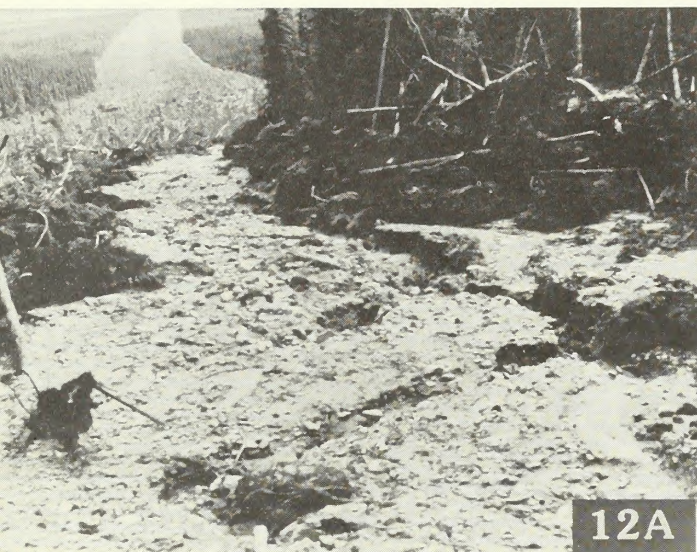
12A

FIGURE 12A--July 1975. The fireline before reclamation. The gully on the right is a result of runoff from the storm that stopped the fire.

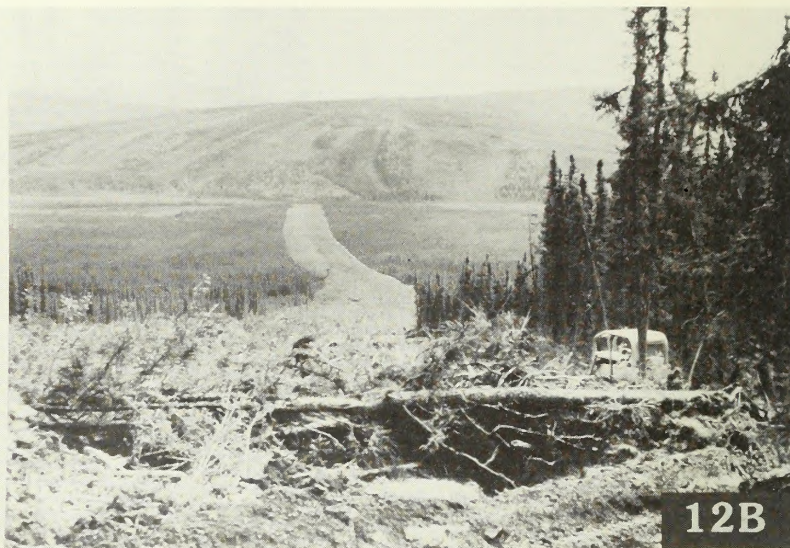
12B

FIGURE 12B--July 1975. This photo was taken while the fireline was being treated. A water-diversion cut is in the foreground.

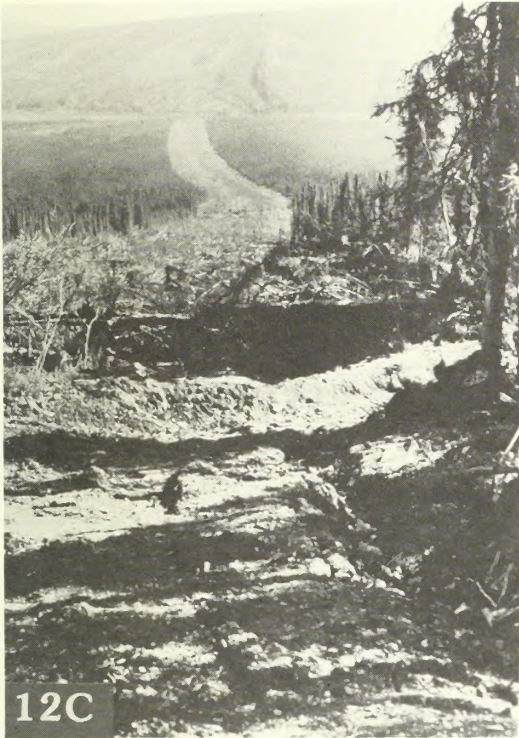
FIGURE 12C--August 1976. Bluejoint and mosses are the major colonizers.

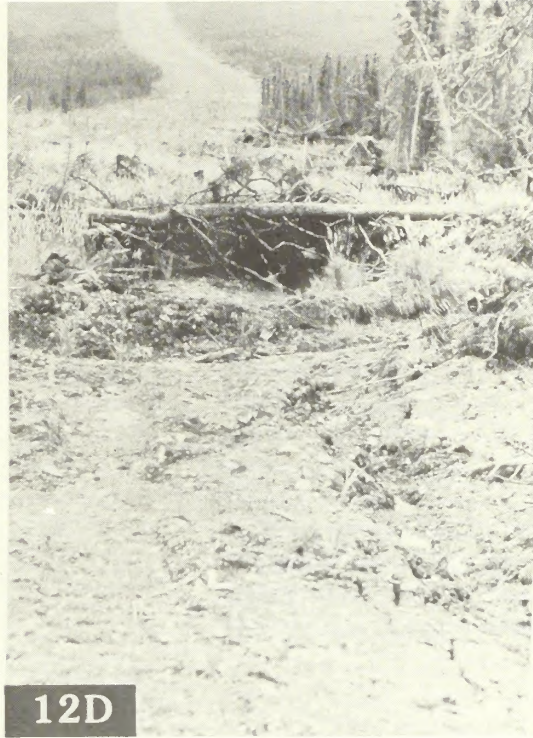
FIGURE 12D--September 1977. Ground cover of grass and mosses has increased since Photo 12C was taken. Erosion has practically ceased.

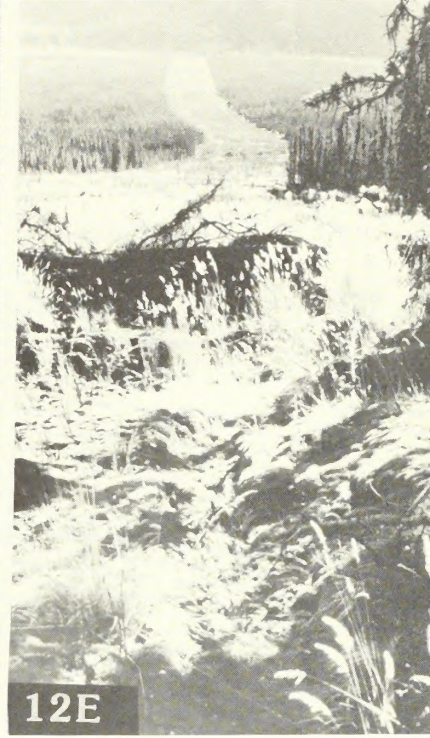
FIGURE 12E--September 1979. Bare ground is almost completely covered, and bluejoint has increased in vigor and density.
